Effective arc fault protection for switchgear

Every data center has two important priorities: to uphold safety and ensure a reliable energy supply. It is therefore vital to protect the building's low-voltage main distribution system against arc flashes, which can cause catastrophic damage. The Hewlett Packard (HP) data center in Rüsselsheim chose to update its switchgear with Eaton technology, including the ARCON arc fault protection system, to ensure the highest levels of safety and reliability.

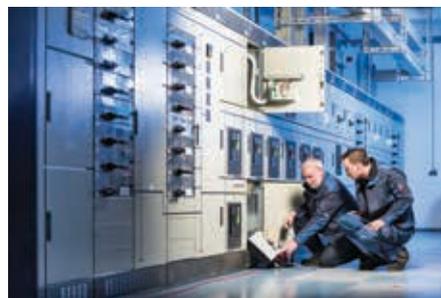
The low-voltage main distribution at the Rüsselsheim data center is based on Eaton's Modan switchgear, which was equipped with the ARCON arc fault protection system when it was first installed.

The low-voltage main distribution contained 20 sections of Eaton's Modan switchgear, which had proved its effectiveness over the preceding two decades. However, ISS and HP decided to implement a new arc fault protection system.

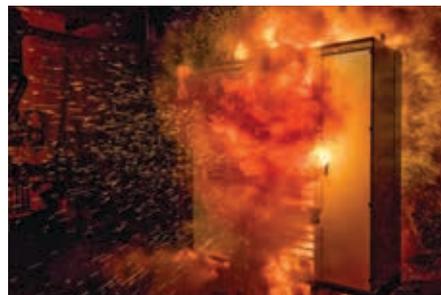
Depending on the circumstances, the effects of an arc flash can be comparable to those of an explosion.

There are many possible causes, including human error while operating the switchgear, contamination, condensation or overvoltage. At their worst, arc flashes can replicate the force of an explosion, with potentially fatal consequences for anyone working on the installation or standing in its vicinity.

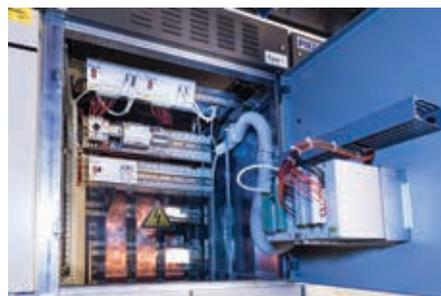
As part of the retrofit project, Eaton secured the six main busbar sections with a new ARCON system, including a door-mounted master module and two slave modules in the control cabinet for current and light detection.

The retrofit project involved the expansion of the old ARCON system, including the optical fibers, as well as the installation of six new ARCON master modules (ARC-EM) for the six busbar sections. Eaton's installation team connected these to two 2.5 megawatt transformers, in addition to a diesel generator and a dynamic Uninterruptible Power System (UPS), which ensure emergency power supply.

After installing and wiring 12 converter sets, as well as the current-sensor modules (ARC-EC1), Eaton also installed new optical fiber technology and 13 sensor modules (ARC-EL3). Furthermore, Eaton configured and commissioned the system, including the completion of functional testing and updating of relevant documentation.

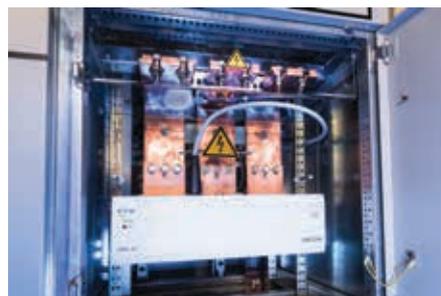
Less than one millisecond after the detection of an arc flash, the ARCON quenching device initiates a three-phase short-circuit, thereby cutting off the arc's energy supply.

The quenching device effectively cuts off the energy supply to the arc. It initiates a three-phase short circuit that diverts the current away from the arc. This short circuit is activated as close as possible to the infeed, in parallel to the fault location, via a built-in pyrotechnic drive, which takes less than one millisecond to perform this function.

The drive accelerates a copper bolt, which punctures an insulating plate and thereby creates an electrical contact. Regardless of its strength, the current takes the line of least resistance, redirecting away from the arc and towards the short circuit instead.
